# Kaikōura – Getting Back to Sea

*Maurice Perwick, Director, Eliot Sinclair*

## *Kaikoura Boat Club Channel Post-Quake*

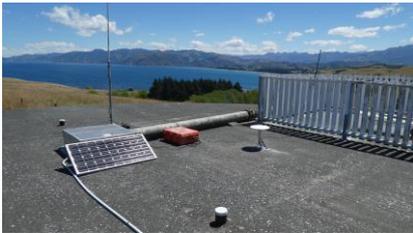
*CCPRS GNSS receiver set up on the old reservoir.*

We had two priorities after negotiating the only open road (Inland Kaikōura-Waiiau Road) in true convoy fashion, vehicle No '200' going in and '18' coming out a week later, and these were to set up our CORS on the old reservoir with a precise Marlborough 2000 Latitude Longitude E Height in terms of NZV16 Geoid and also to set up a tide pole and gauge in the Whale Watch Marina.

So, while Liam and Quentin, my two Survey Graduates, set up the GNSS Receiver up the hill, I was establishing my acoustic tide gauge on the wharf edge.

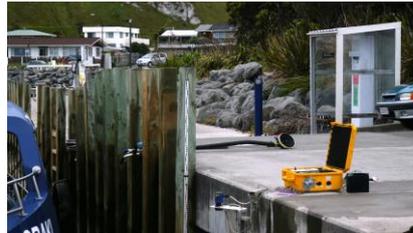
*Establishing acoustic tide gauge on the wharf edge.*

LINZ had supplied us with detailed tide prediction data which allowed us to determine the reduced level of the wharf and the probe height of our acoustic sensor which measured downwards (Nadir) to the water surface.

We were able to establish a tide pole on some bulwarks and synchronise the gauge to the pole.

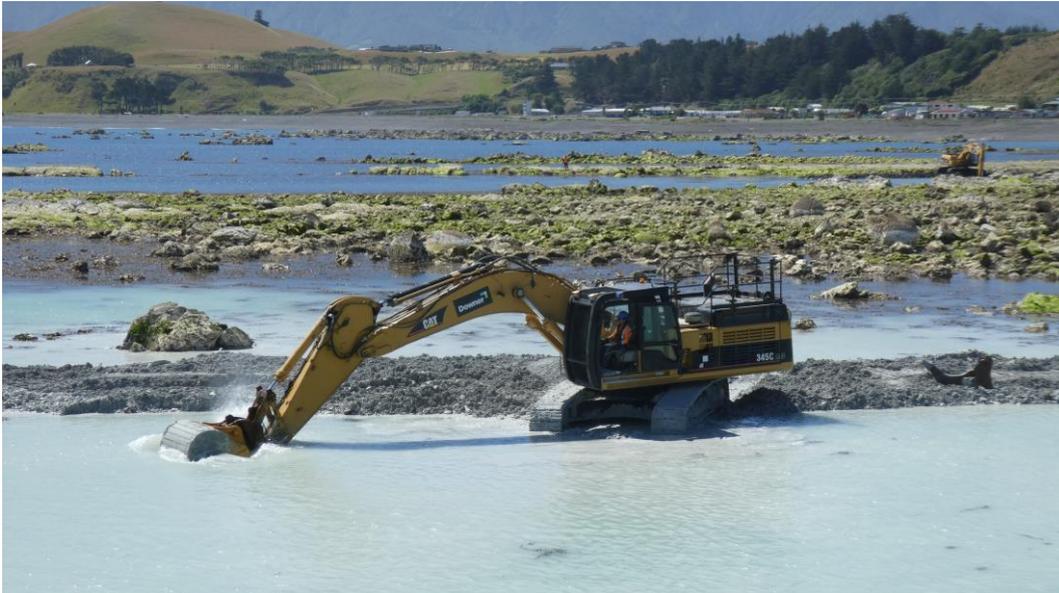
*Note the amount of exposed seabed behind the digger.*

A simple and straight forward method in shallow water is to create a bund, or embankment, and then excavate to the design depth and remove the bund as you withdraw.

The limestone seabed can be ripped with a single ripper tooth and excavated with a 35 Tonne digger. The material can be used to extend the bund and can be immediately driven on. The low tide bund maximised the reach of the digger and their efficient removal of seabed rock.

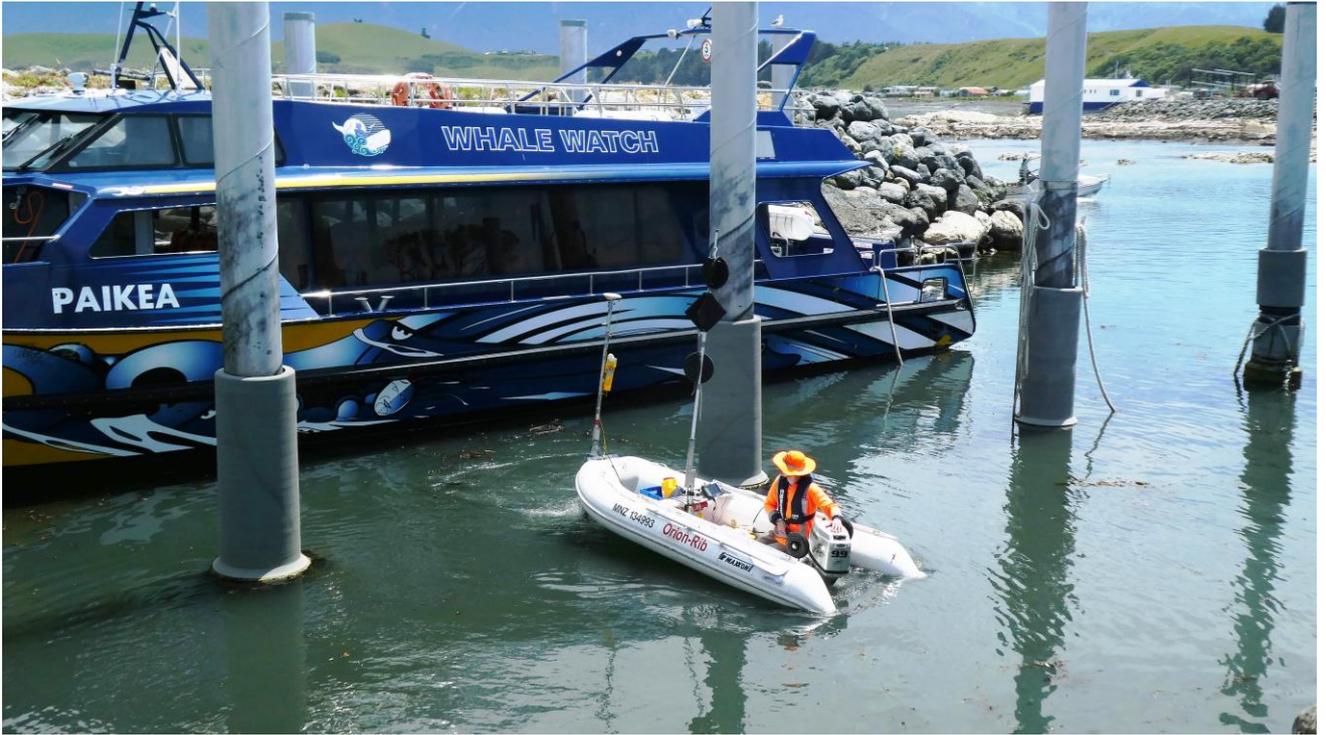
We were able to prove the datasets from each of the technologies were consistent as we sounded over a shoal at high tide which had been exposed at low tide to the LiDAR aircraft. The results are impressive.
