Media Release - New Zealand Institute of Surveyors (NZIS)

Unmanned Aerial Vehicles (UAV's) a large part of the Kaikoura solution

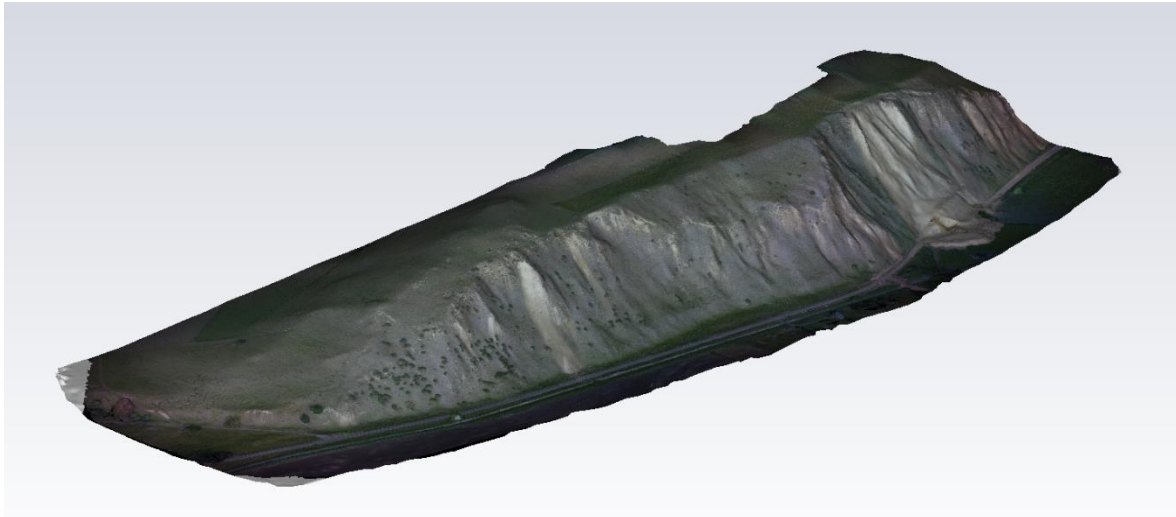
Perspective image created of part of the Kaikoura SH1

Surveyors used a 1.8m span octo-copter to take a series of photos which were then further processed to provide 3d models of the major Rotherham land slip. There are of course, many slip and damaged areas to be flown, mapped and assessed with modelling experts to the forefront of this work. The outcome is something we can all be proud of that these communities are slowly reopening and recovering.

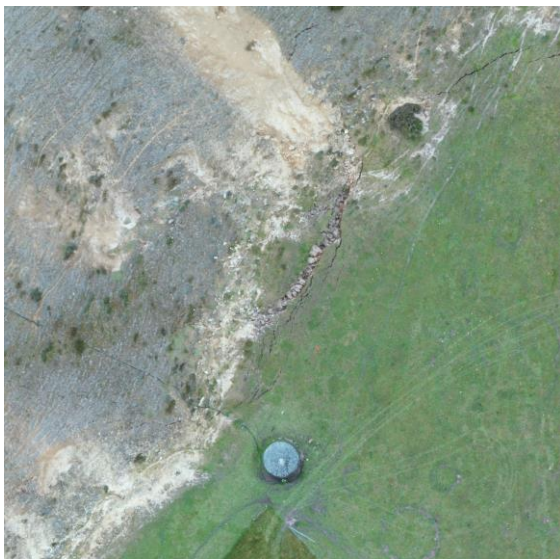
Fractures at the top of an escarpment
